## Immediate Action Required User Safety Notice SN070523

3M™ Scott™ Air-Pak™ Wireframe, Air-Pak™ 75, Air-Pak™ NxG7 (Upgraded), Air-Pak™ X3 SCBA and Spare Assemblies

May 2021 – February 2023

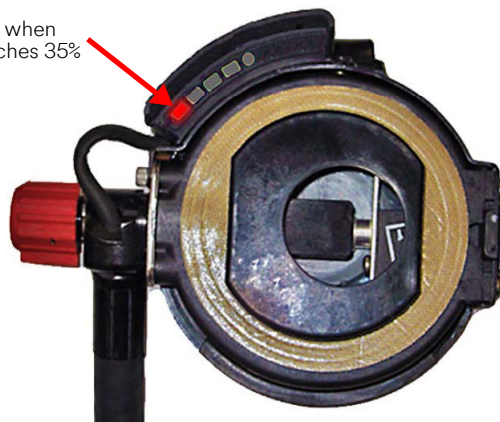
Figure 1

3M™ Scott™ Fire & Safety has received a small number of reports of Air-Pak 75, Air-Pak NxG7 (upgraded), Air-Pak X3 SCBA and spare consoles that were shipped with incorrect programming of the Heads-Up Display (HUD) secondary EoSTI. In the reported cases, although the Vibralert primary EoSTI will alarm at 35% of cylinder pressure in accordance with regulatory requirements, the HUD console lights will only indicate low air (red flashing light as illustrated in **Figure 1**) when the cylinder pressure reaches 25%. While both signals are measuring accurately, the HUD lights for these SCBA editions should be illuminating at 35%.

Red light should flash when  
cylinder pressure reaches 35%
